RICHMOND PRIMOID, INC.

RICHMOND PRIMOID: SOMETHING TO CHEER ABOUT AT LANE STADIUM

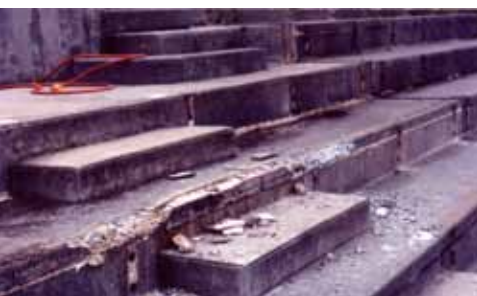
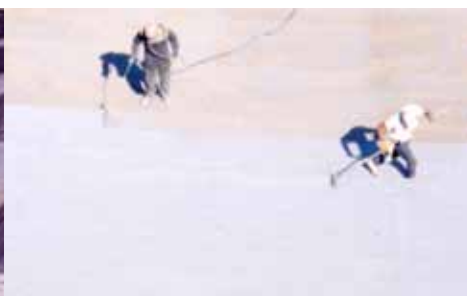
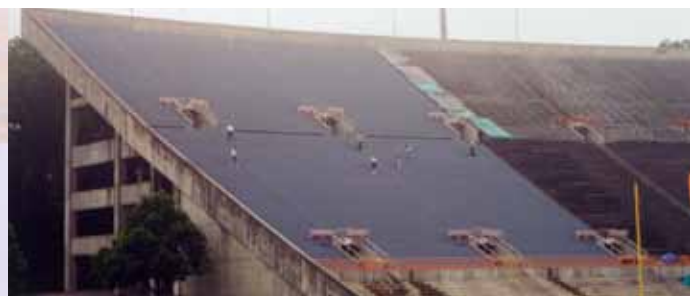
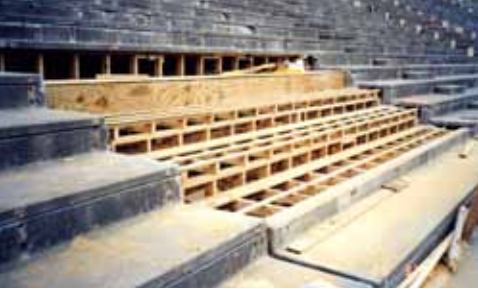
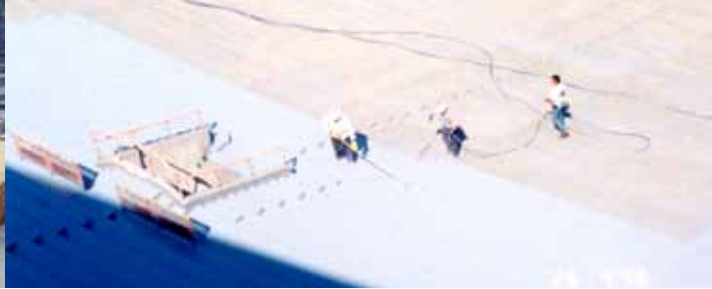
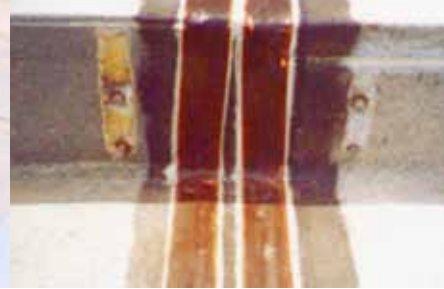
The Problem: Over the years, weather and water penetration lead to the deterioration of several stadium sections, most noticeably on the seats and steps. It was important to put a stop to this problem immediately. Left unattended, such damage could have caused a loss in structural integrity in future years. Before any work could get underway, Richmond Primoid first had to remove the 50,000 seats just to get to the damaged area. This was quite a job in itself.

"The whole process was very labor-intensive" explains Al Rose, President of Richmond Primoid. "For one thing, the seats were secured by anchor bolts that were in pretty bad condition. The bolts were so rusted they tended to break when we tried to remove them."

The Solution: Work began with the removal of the seats and caulking. Next, the deteriorated concrete was cut away and hauled out of the stadium. The joints were then ground clean to remove any existing film. This left a fresh surface for better adhesion. After that, the rusted seat bolts were cut out and new holes drilled for each bolt. This process was repeated for some 4,000 bolts.

The fourth step involved repairing the deteriorated concrete around the steps and seating areas. For that, Richmond Primoid used concrete and a polymer modified patching material. This type of patching material was chosen because its density adheres well to the shape into which it is molded. Once the concrete and patching material hardened, the entire stadium was power washed.

Next came recaulking both the vertical expansion joints and the horizontal joints running behind and along the seating areas. After the expansion joints were caulked, a rubber membrane was applied over each vertical joint for greater flexibility. In all, Richmond Primoid removed and replaced 87,000 feet (16.48 miles) using Pecora Dynatrol II caulking to seal the joints around 50,000 seats.

to apply over 8,500 gallons of Neogard Peda-Gard II Waterproof Traffic Bearing coating to 263,000 square feet of surface. Neogard is a urethane coating applied in four layers. The first two of those layers were used to seal out moisture. The third coat was mixed with an aggregate creating a non-slip surface. The final coat then locked in the aggregate. Colored gray with orange and maroon highlights, the Neogard dried, forming a protective coating perfect for use in heavy traffic areas. Adds Rose, "We've been using this type of coating for 30 years without a problem. When we find something that works, we stick with it."
